# OAKVILLE COACH HOUSE

David Lasker +VG Architects

The official opening of the picturesque, Shingle Style Oakville Coach House last year marked the completion by +VG Architects (The Ventin Group Ltd.) of the adaptive reuse of the Erchless Estate, a cultural heritage property designated under Part IV of the Ontario Heritage Act as an intact surviving example of an estate developed by a wealthy settler family at 8 Navy St. in Oakville, Ontario.

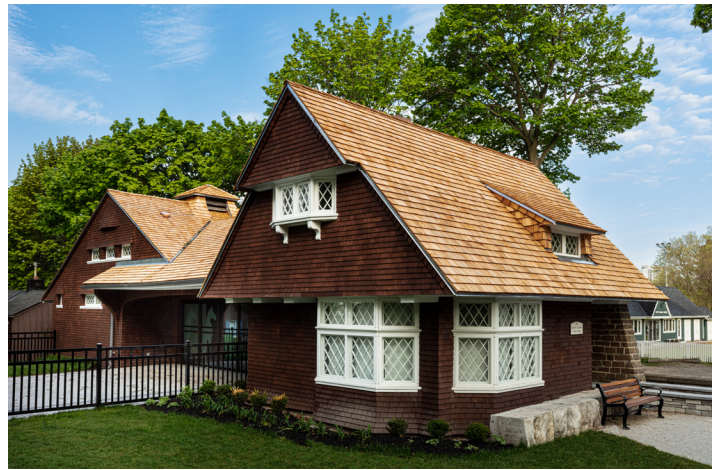
The Coach House from the southeast with the gardener's cottage in the foreground.

The building comprises three-parts: horse stables and tack area, a coach storage with hayloft extending across both; and a two-storey gardener's cottage. The exterior charms the eye with eclectic features such as the steeply pitched cross-gable roof and its irregular slopes, eyebrow dormers, bell-cast and bowed projections, shingled cupola, and bay window and mullioned windows.

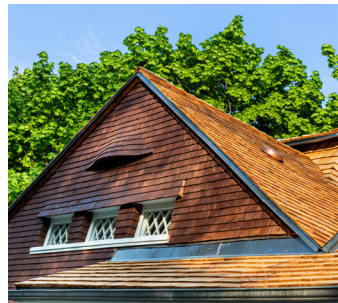
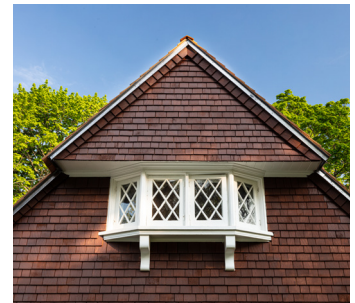
Close-up from the south of the steeply pitched, cross gable roof clad in wood shingles (L)  
Close-up of the corbeled oriel window on the south façade of the second storey of the gardener's cottage (R).

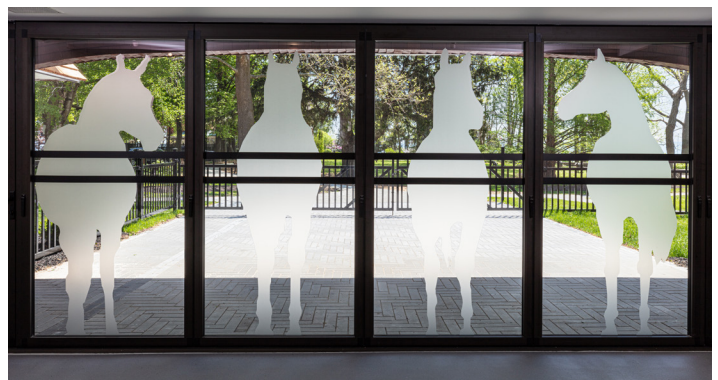
The south façade's barn doors added during a 1997 renovation were replaced with a new operable glass wall panel system with a film graphic depicting horses.

The other modern adaptation to improve accessibility is at the south façade, where the existing barn doors (added during a 1997 renovation) were replaced with a new operable glass wall panel system that slides into a side pocket, providing visual access from the multi-use space (formerly the carriage storage area) to the gardens and estate beyond. A film graphic on the glass panels depicts horses, reflecting the structure's initial use while deterring bird strikes.

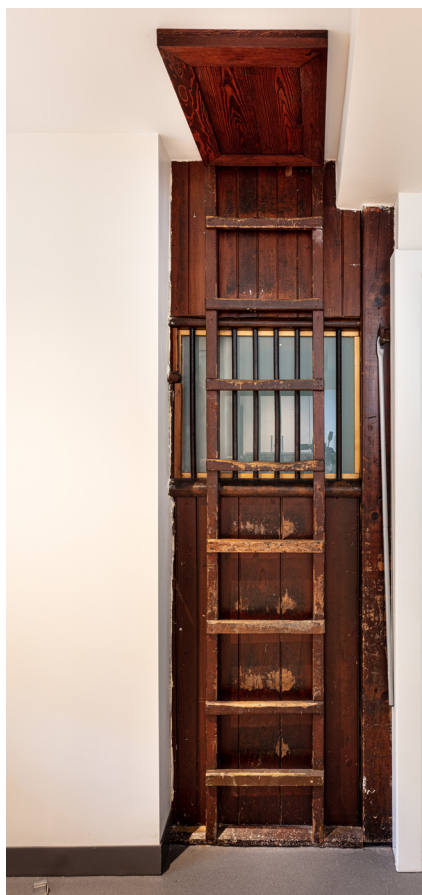
In the stable area, the original ladder to the hayloft and its trapdoor, and their patina, were conserved.

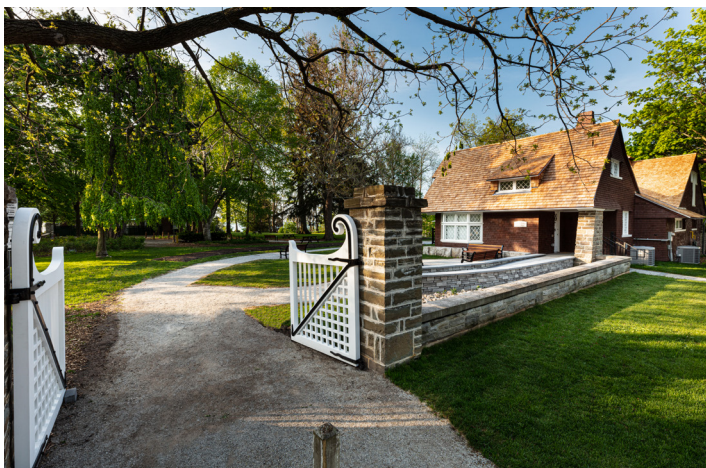
The ornamental wooden gate at King Street, a significant landscape feature, leads to the Coach House's east entrance. A barrier-free entrance was created by rebuilding the existing porch 46-cm higher with the entrance preceded by a gently sloping path over an archaeological zone that brings the visitor to the level of the door threshold.

A barrier-free entrance was created on the east side by rebuilding the existing porch 46-cm higher with the entrance preceded by a gently sloping path over an archaeological zone that brings the visitor to the level of the door threshold.
